# Valero Energy Corporation Improves Batch Control and Reduces Maintenance Costs with Rosemount™ 3051S Thermal Range Expander

Level measurement in a stripper column with a steam injection near the bottom

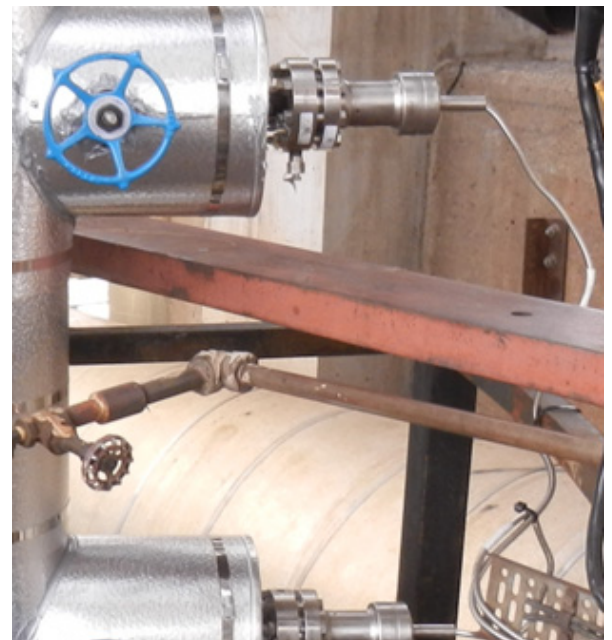
*Rosemount 3051S Thermal Range Expander installed in application #2*

### Application #2 Solution

The Rosemount 3051S Thermal Range Expander was installed next to the competitive unit for comparison and operation began in May of 2014. Rosemount's solution had no glycol column and was fully insulated with heat-traced wet-legs (not required, system could have been direct mounted). Additionally, the Thermal Range Expander met the extreme hot process and extreme cold ambient temperature requirements. To date, the Thermal Range Expander system has not required any maintenance, provides no long-term drift, and provides peace-of-mind for reliable operation through the winter.

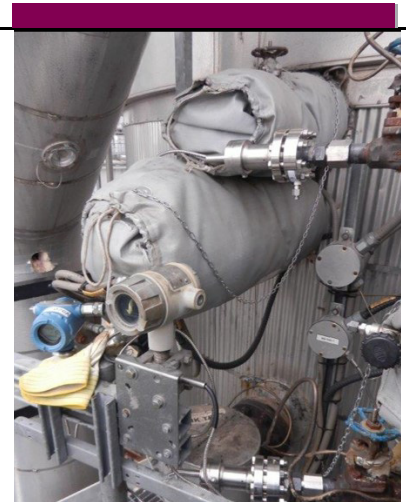
*Rosemount 3051S Thermal Range Expander installation in application #1*

### Application #1 Solution

A Rosemount 3051S Thermal Range Expander system was installed in January 2014 with a customer-specified threaded remote seal instrument connection. The primary and secondary fill fluids were Silicone 705 (370 °C) and Silicone 200 (-45 °C), respectively. The Emerson™ solution provided easy installation without a crane and reliable operation year-round with no maintenance. The Rosemount 3051S Thermal Range Expander also showed a 53 percent decrease in process level variation/noise which resulted in lower actuation of process level valve. In addition, Rosemount's solution performed as designed at a near record low ambient temperature of -26 °F (-32 °C) on January 22, 2014 which has provided peace-of-mind operation in worst-case conditions.
