Emerson's Condition Monitoring Solution helps Arabian Cement Company protect its critical assets and prevent 70,000-ton production loss

Online Machinery Health Monitoring of a gearbox in a horizontal ball mill.

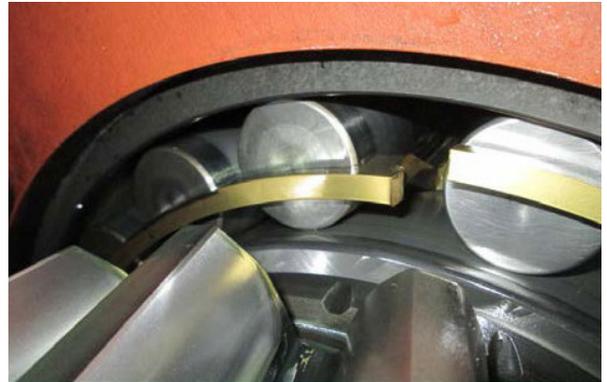
Emerson’s Online Machinery Health Monitoring solution monitored the condition of a fracture in the gearbox’s bearings’ cage allowing safe production for 17 days.

The ACC plant operates four horizontal ball mills that are driven by a 6-megawatt gearbox, helping to produce 185 tons of cement per hour for each mill. In December 2014, the plant team detected a sudden increase in the vibration levels of the gearbox, and consequently by inspection discovered a fracture in one of the gearbox's bearings.

The cement mill had a smooth and safe production for 17 consecutive days, until the online monitoring began to detect a condition that went against the running parameters set for the equipment. Consequently, Emerson was consulted by the plant team and the team was advised to stop the mill for inspection, which revealed that they had a complete failure of the bearing cage. Accordingly the mill was stopped for repair in order to prevent any further failure or damage. The repair was carried out and the mill was back in steady operation with full capacity in January 2015.
